# New York State Department of Transportation

## Yellow Flag NB23U4W018

**BIN: 1065318**

Location: Span 231 Stringer S2 at Pier 230

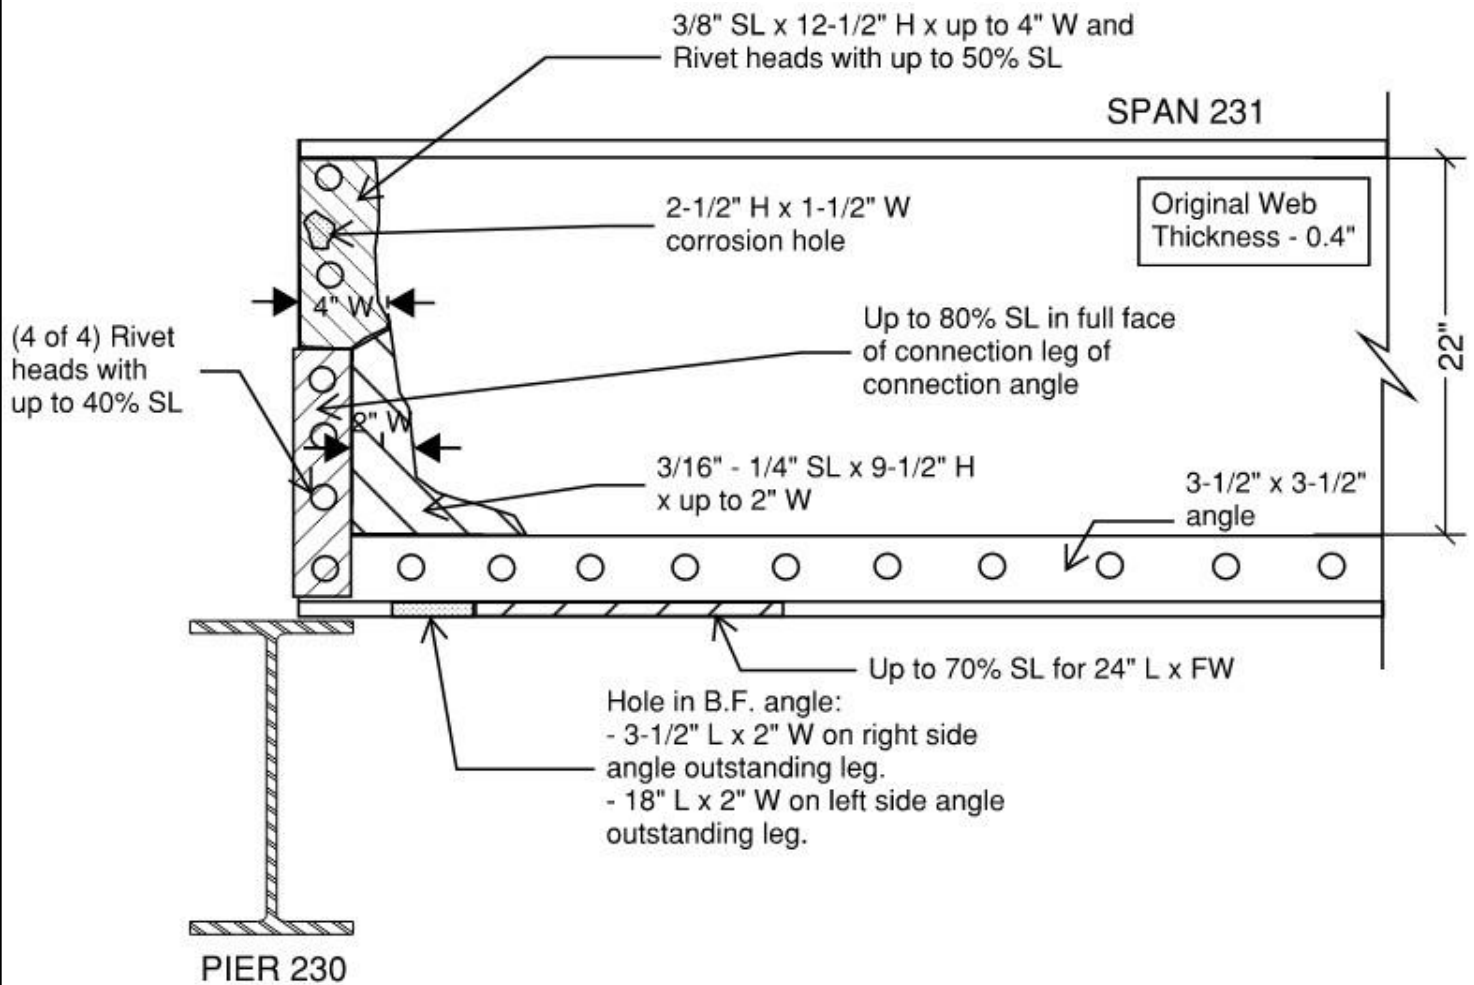
Photo Number: 2

Refer to sketch for further details.

**SPAN 231, STRINGER S2 AT PIER 230**  
**(LOOKING LEFT)**  
**N.T.S**

*Attachment Description: Flag Condition Sketch*

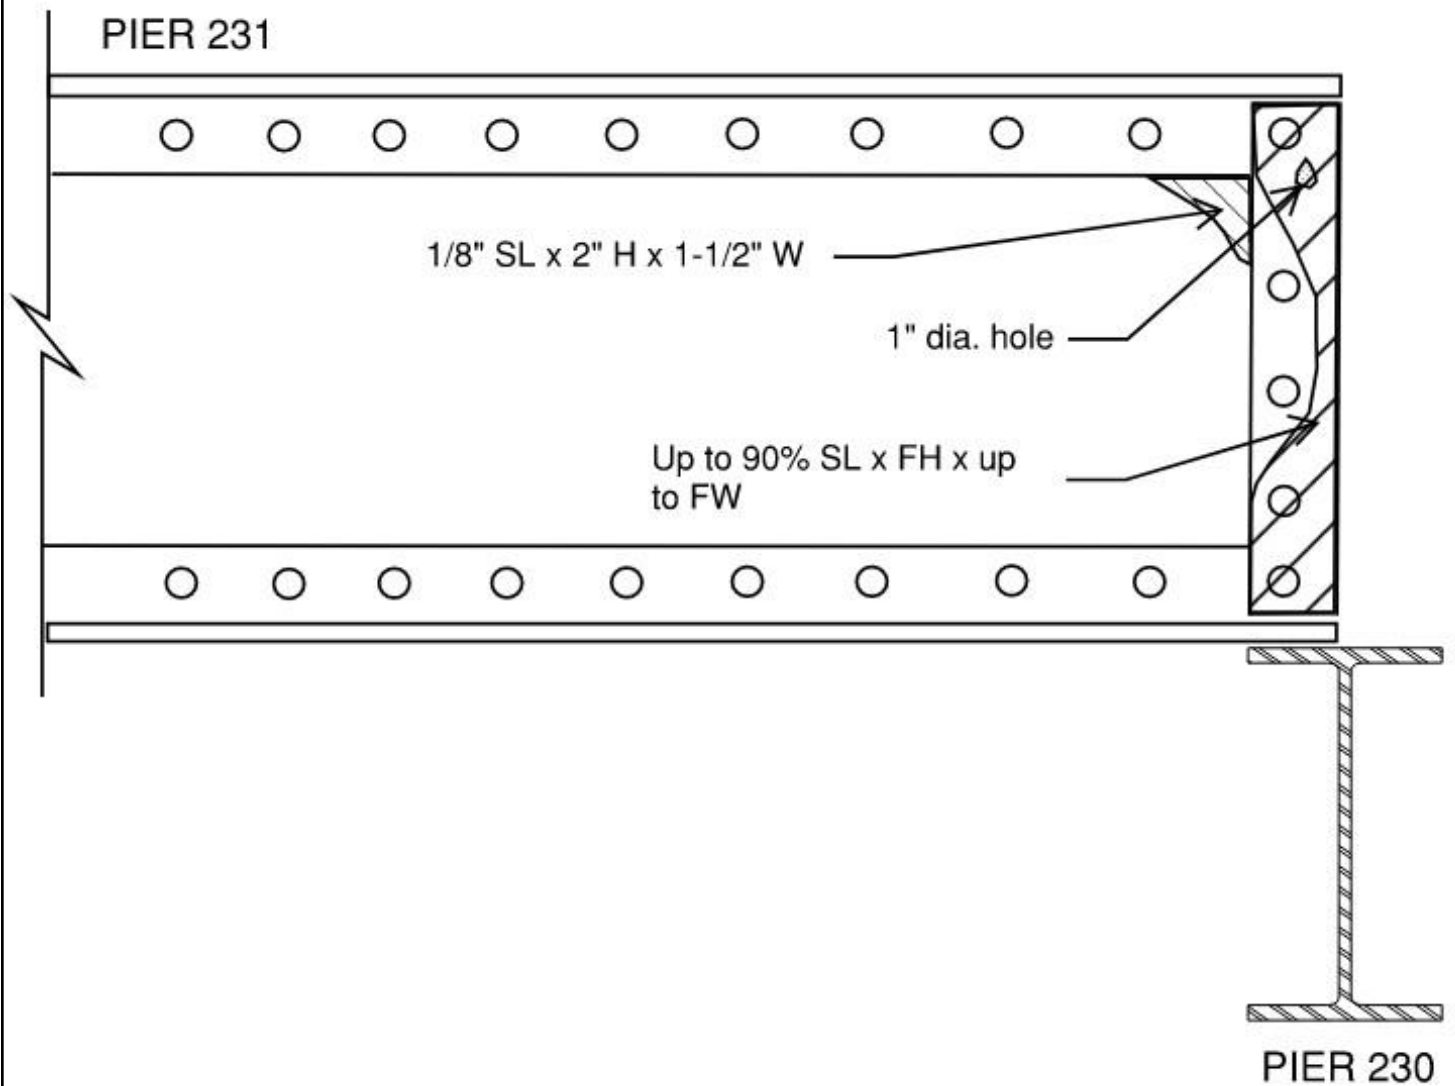
Photo Number: 3

**SPAN 231, STRINGER S2 AT PIER 230**  
**(LOOKING RIGHT)**  
**N.T.S**

*Attachment Description: Flag Condition Sketch 2*

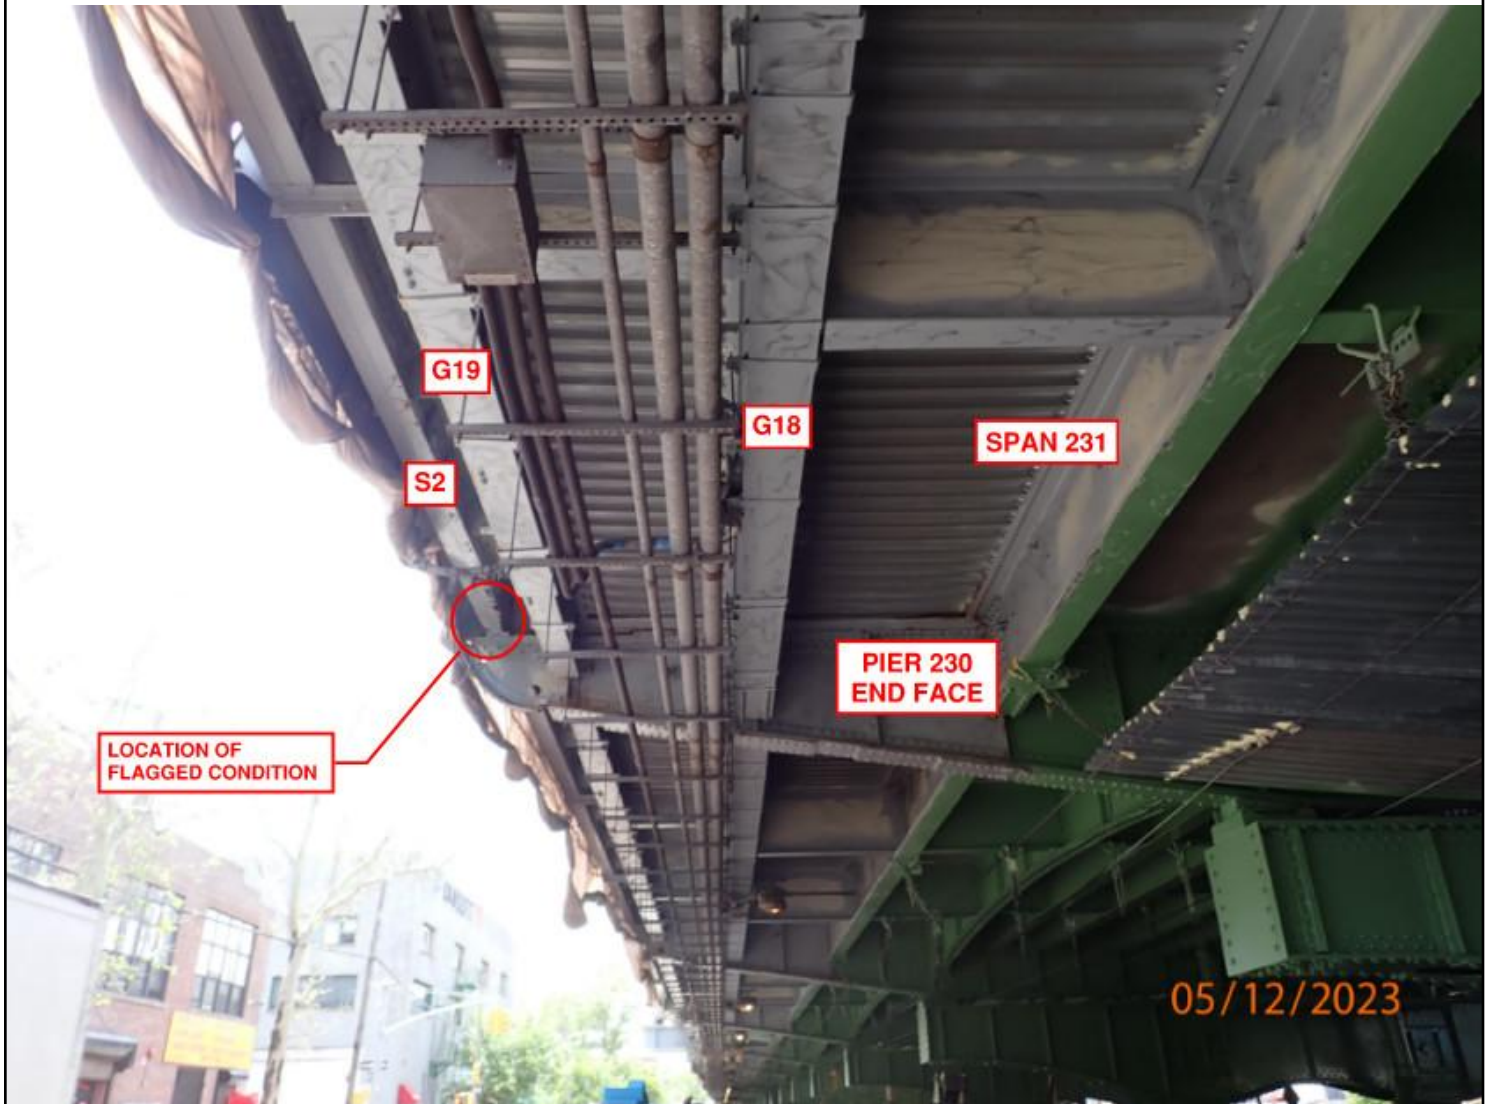
Photo Number: 4

**Attachment Description: General View of Flag Location. Looking Begin-Up.**

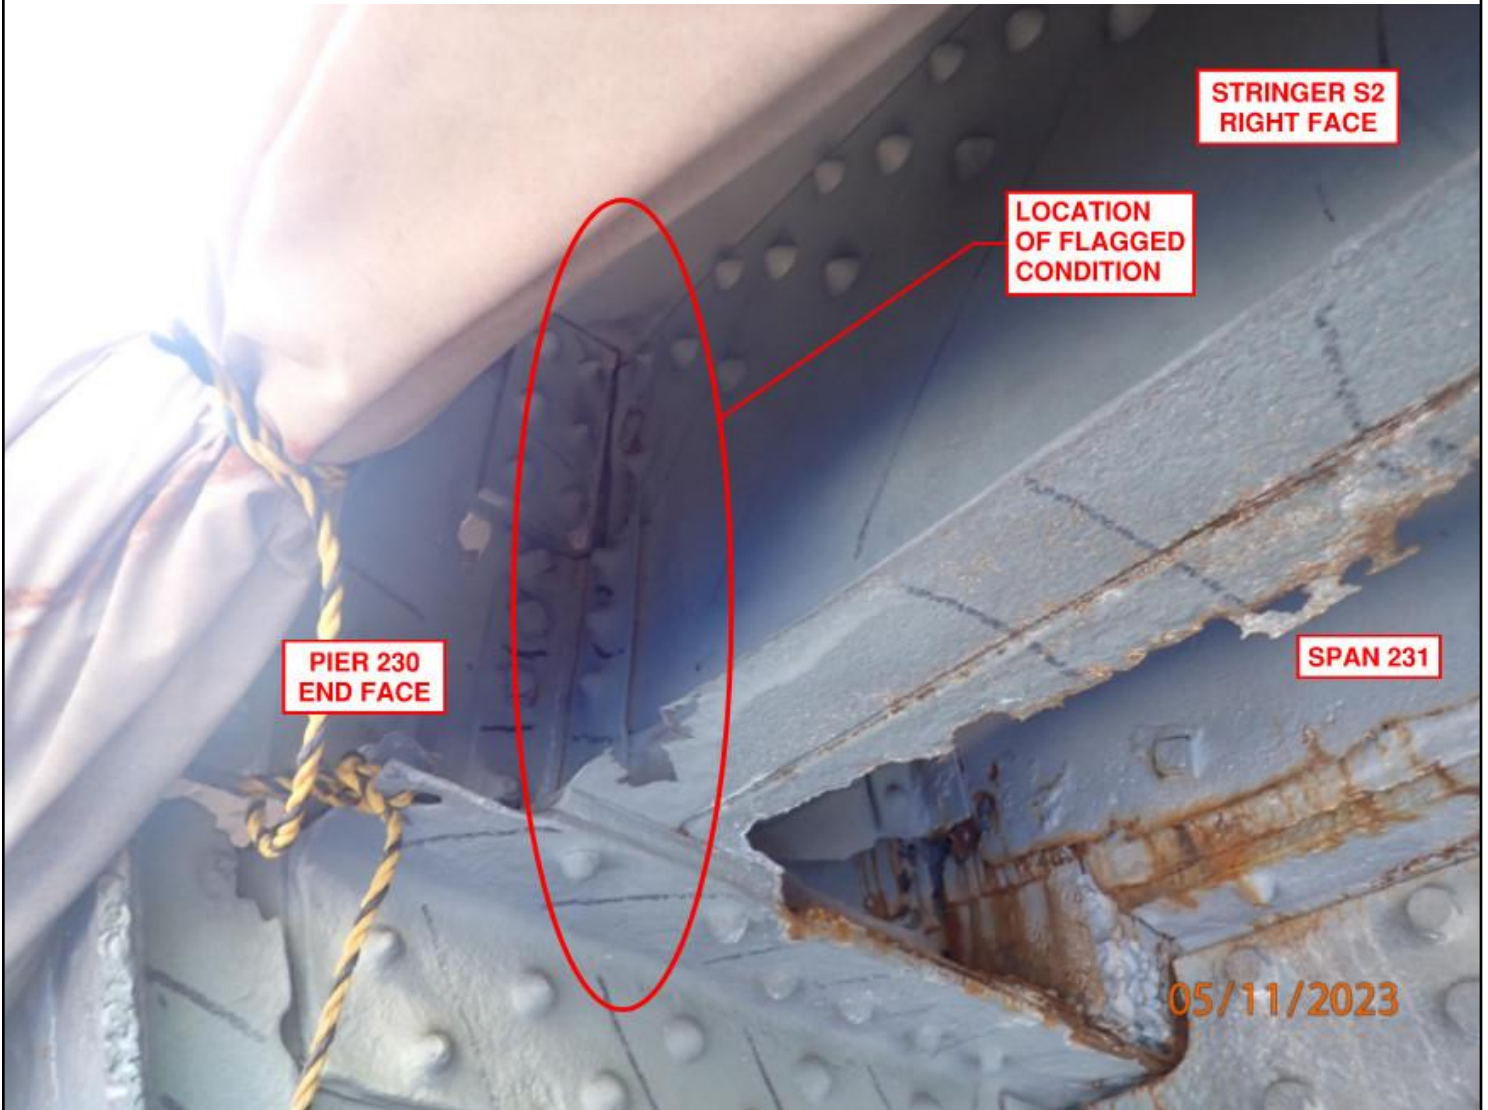
Photo Number: 5

Stringer S2 web right face exhibits a 2-1/2"H x 1-1/2"W corrosion hole in the upper web with 3/8" section loss (12-1/2"H x up to 4"W) around the corrosion hole in the upper web. Remaining height of the web exhibits 3/16" to 1/4" section loss (9-1/2"H x up to 2"W) adjacent to the connection angle. Connection angle on right face has up to 80% section loss on the full face with 40% section loss in 4 out of 4 rivet heads. Bottom flange angle on right side exhibits a 3-12"L x 2"W hole in the outstanding leg.

**Attachment Description:** General View of Flag Condition on right face of stringer web. Looking Begin-Left.

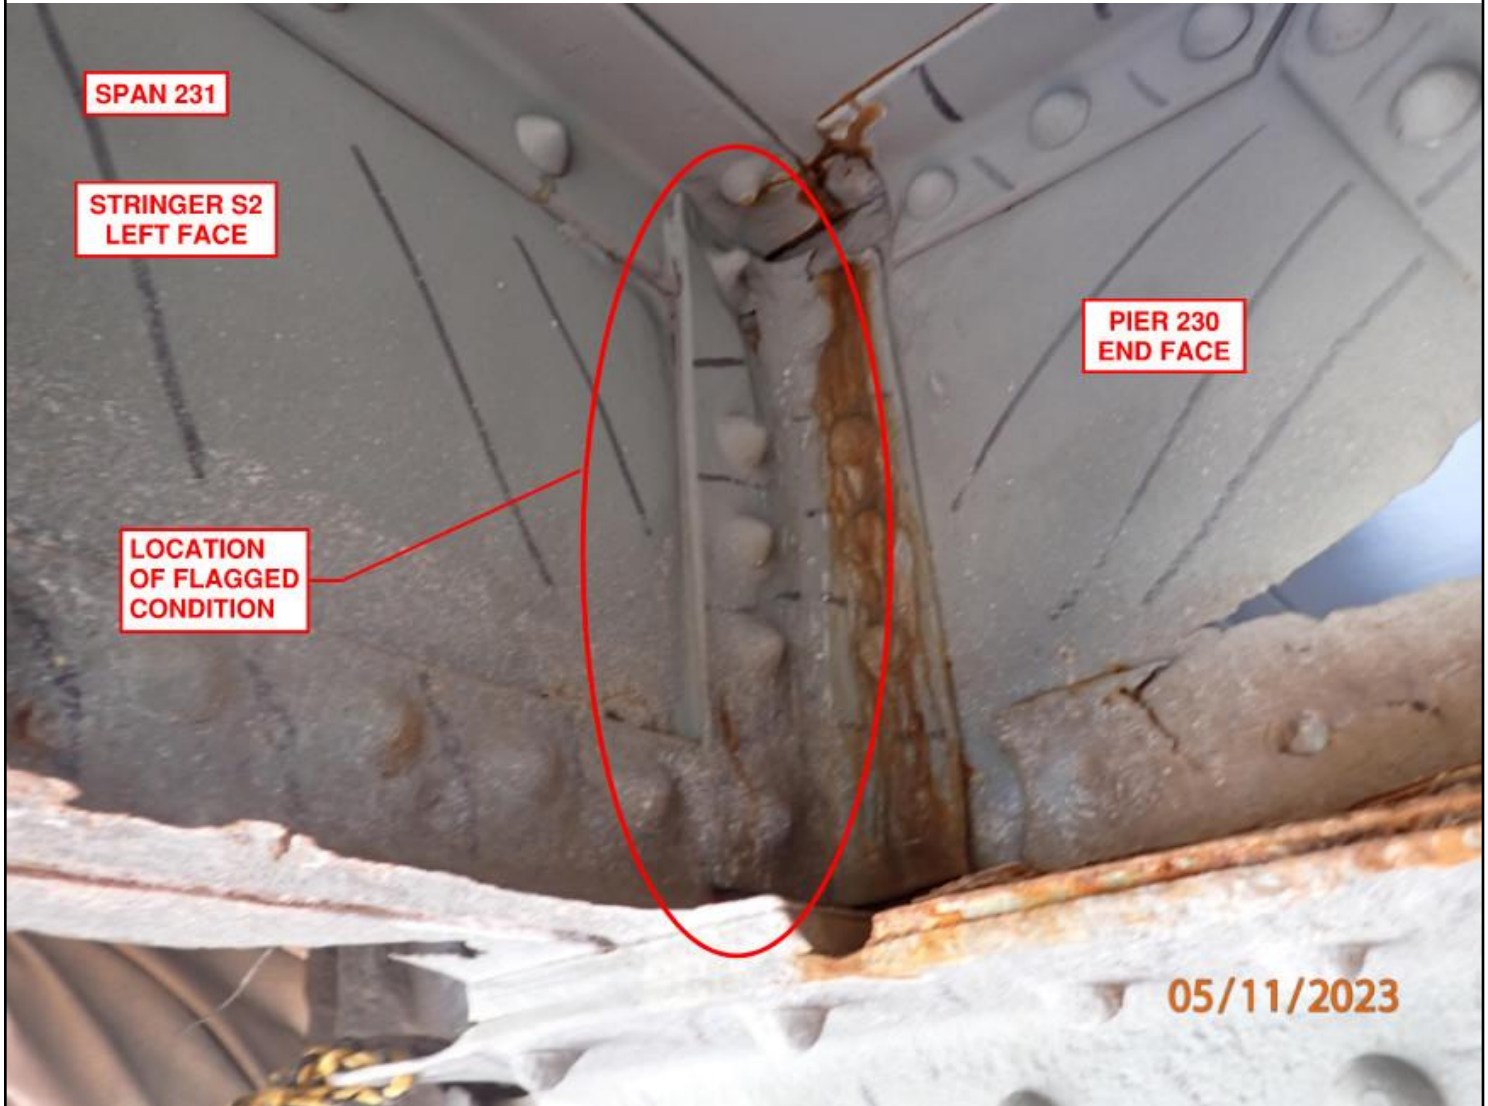
Photo Number: 6

Stringer web left face exhibits 1/8" section loss over a small area of 2"H x 1-1/2"W in the upper web below the top flange angle. Connection angle on left face has up to 90% section loss on Full Height x up to Full Width, with 1" diameter hole in top of the connecting leg. Bottom flange angle on left side exhibits a 18"L x 2"W hole in the outstanding leg.

**Attachment Description:** General View of Flag Condition on left face of stringer web. Looking Begin-Right

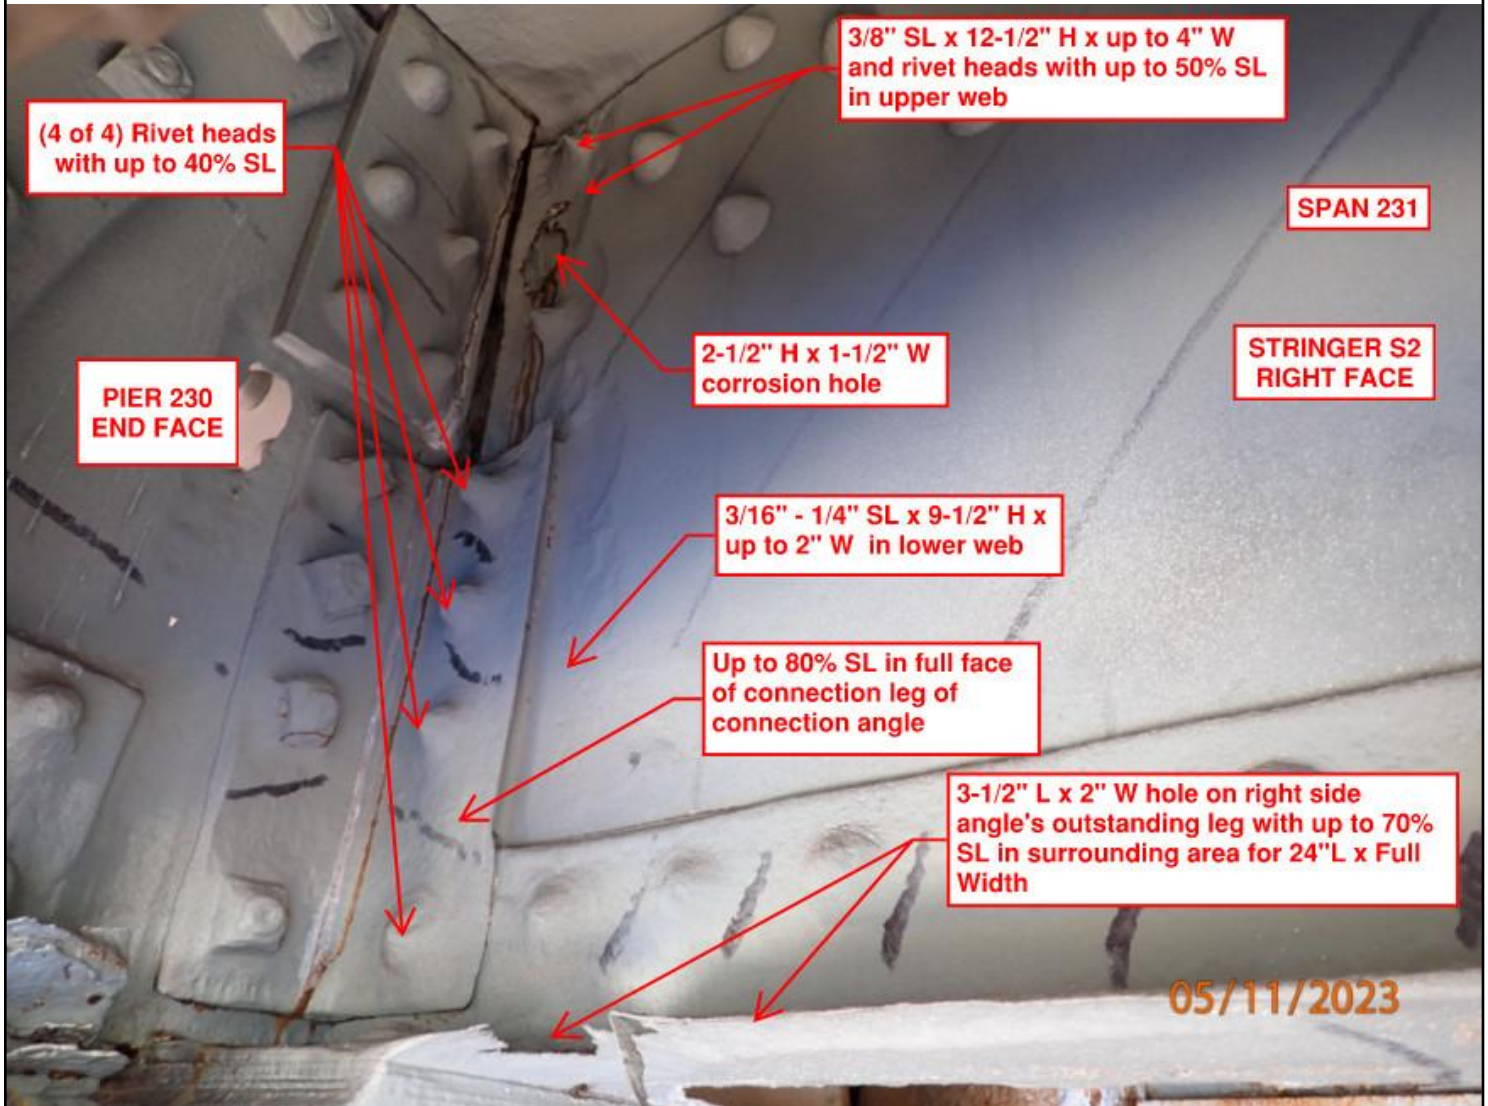
Photo Number: 7

**Attachment Description:** S2 right face has a 2-1/2"H x 1-1/2"W corrosion hole in upper web with 3/8" SL (12-1/2"H x up to 4"W) around corrosion hole in upper web. Remaining height of the web exhibits 3/16" to 1/4" SL (9-1/2"H x up to 2"W). Connection angle on right face has up to 40% SL on full face. Bottom flange angle on right side exhibits a 3-12"L x 2"W hole in the outstanding leg. Looking Begin-Left

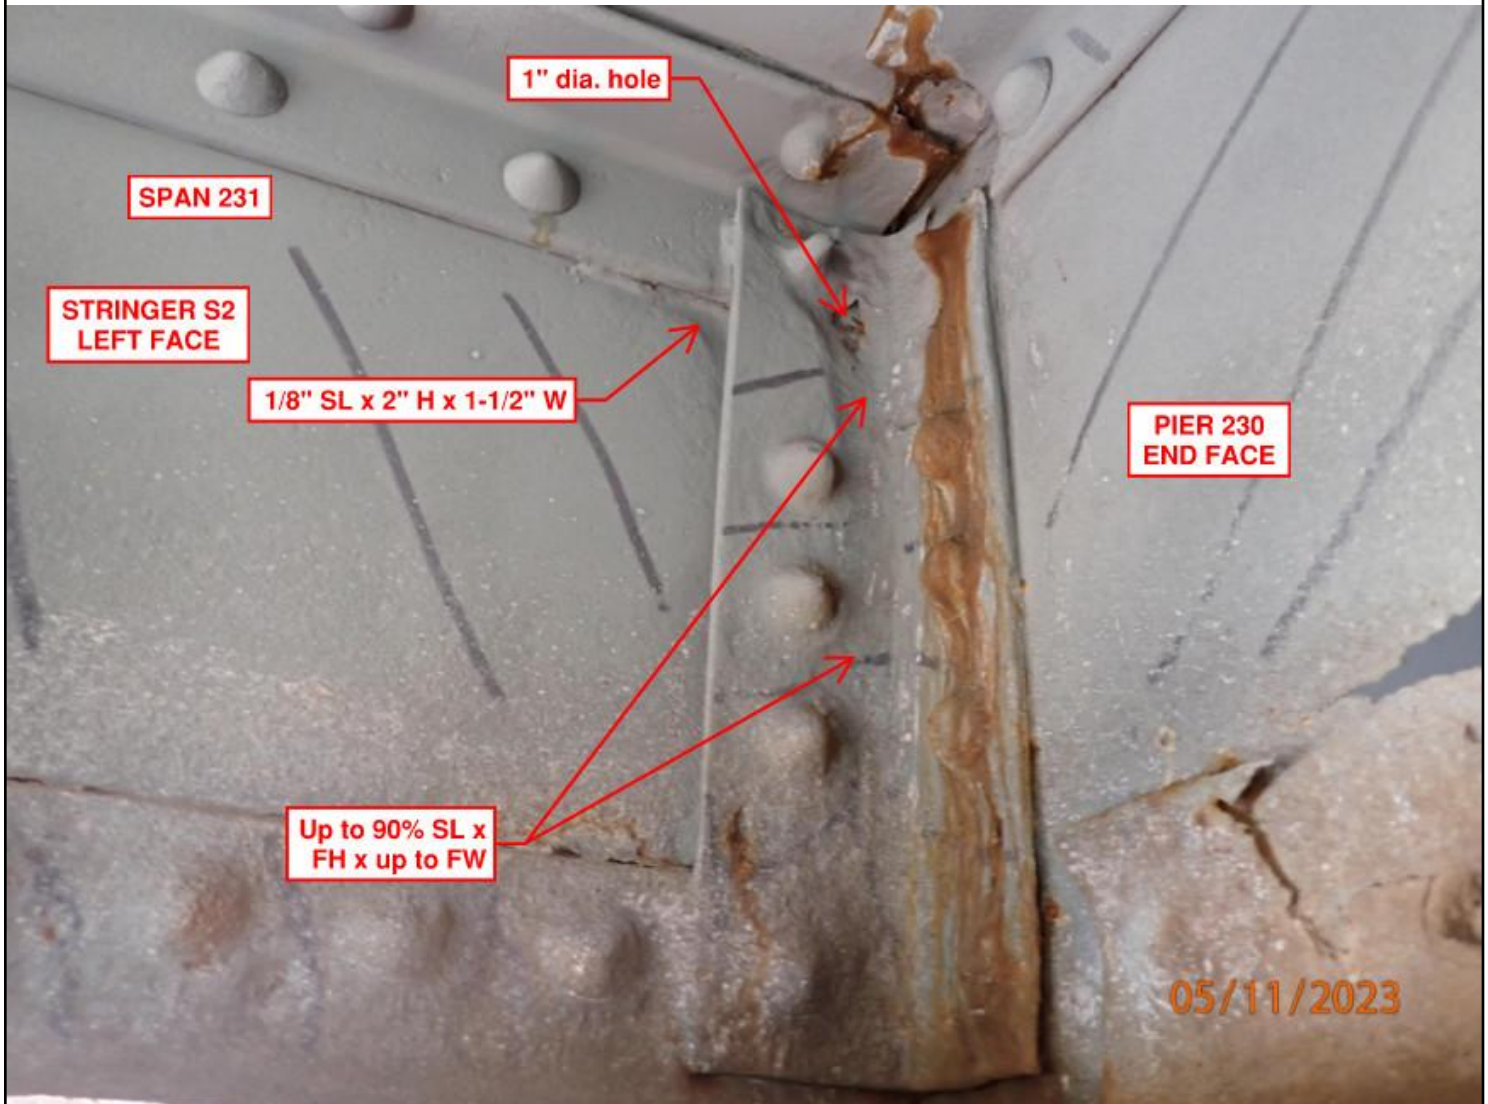
Photo Number: 8

**Attachment Description:** Stringer S2 web left face exhibits 1/8" section loss over a small area of 2"H x 1-1/2"W in upper web below top flange angle. Connection angle on left face has up to 90% section loss on FW x up to Full Width, with 1" diameter hole in top of the connecting leg. Bottom flange angle on left side exhibits a 18"L x 2"W hole in the outstanding leg. Looking Begin-Right
